PHASE I INSPECTION REPORT
NATIONAL DAM SAFETY PROGRAM
TENNESSEE

Name of Dam Chancellor and Son

County Hardeman

Date of Inspection March 10, 1981

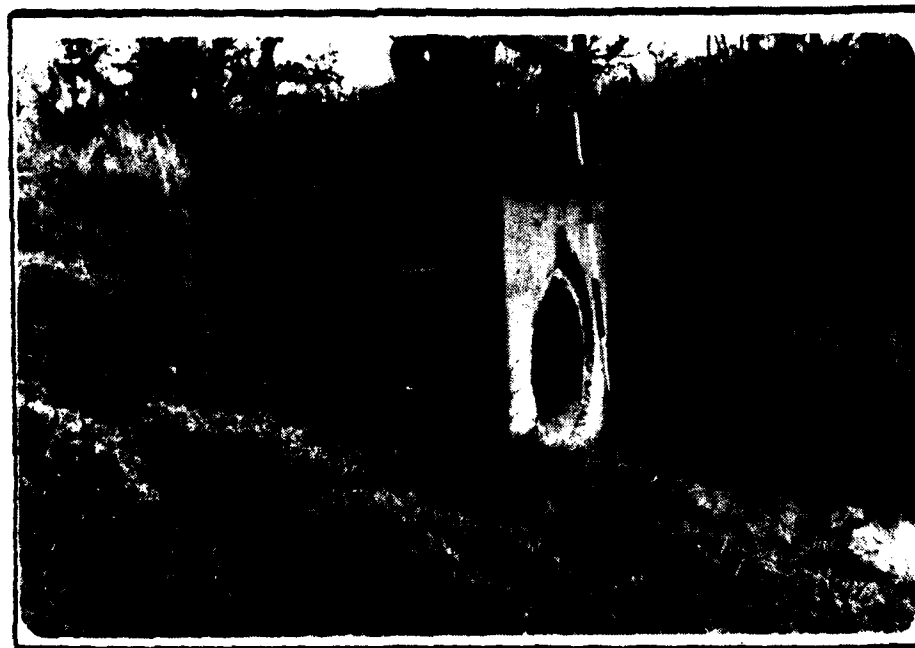
PHOTO NO. 8

Photo No. 8 - The outlet of the service spillway. (Note the lack of fill over the pipe behind the headwall.)

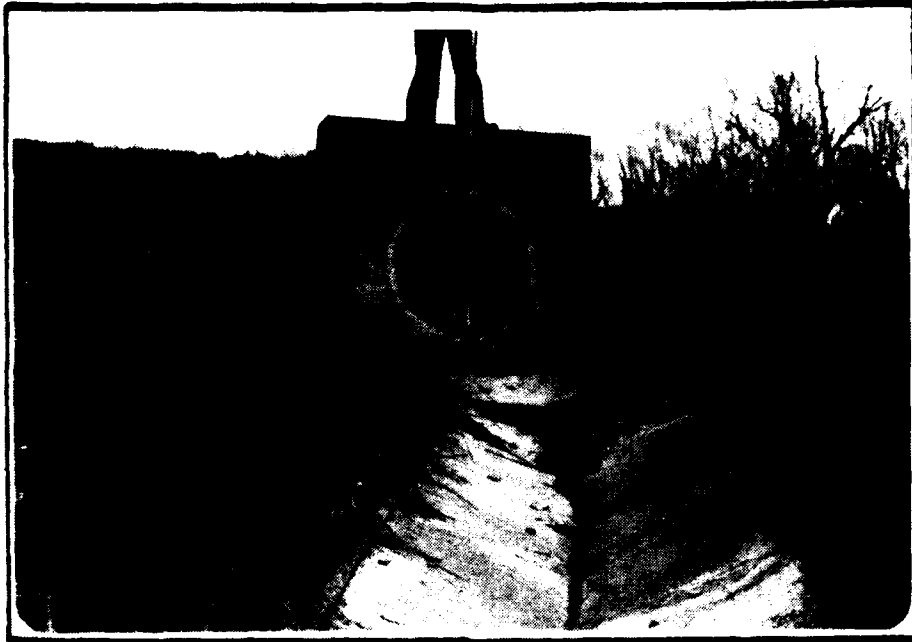
PHOTO NO. 9

Photo No. 9 - The outlet of the service spillway and the chute leading down the slope. (Note concrete plug in invert of pipe.)
